JABIRU AIRCRAFT PTY LTD

SERVICE BULLETIN: JSB 044

Subject: Jabiru Control Surface Hinge Inspection

Affected Models: All models

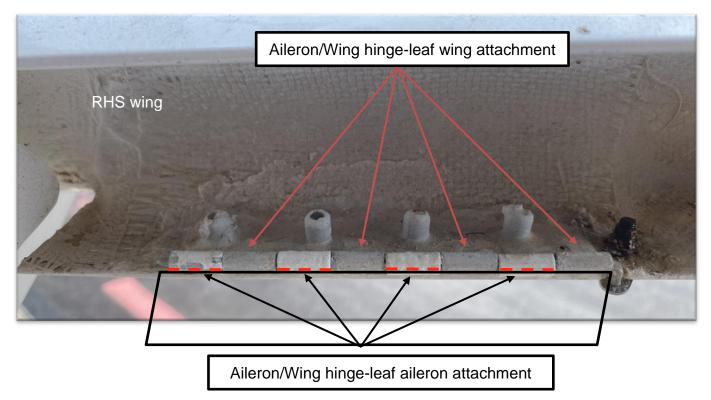
- Jabiru Aircraft has been made aware of an aileron hinge failure detected during a preflight controls check on a 20 year old Jabiru SP4 aircraft. The aileron hinge failed in fatigue on the hinge leaf attached to the aileron. With no connection the leading edge of the aileron was able to droop down, if this occurred inflight, aileron control could have been lost or severely impaired. Figure 1 shows the failed aileron hinge, showing where the failure occurred. Note that the hinge pin securing screw and other hardware of the aircraft had visual signs of corrosion.

Figure 1: Failed hinge (leaf on wing detached from leaf on aileron)

If a hinge pin is found to be seized from corrosion or a hinge leaf cracked, corrective action must be taken before any further flight. This will most likely involve replacing the hinge.

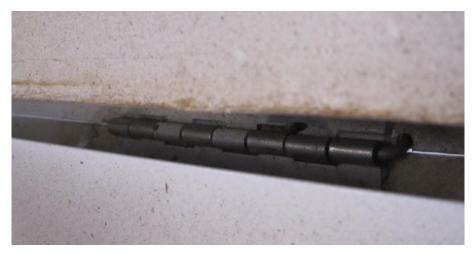
1) Inspect each hinge visually from below and above, if possible. A torch is required. Note that paint can hide cracks or show false cracks so careful inspection is required. Parts should be free from corrosion. Corrective action must be taken for corroded parts. (Extensive corrosion is evident in Figure 2.)

Figure 2: Aileron hinge from above

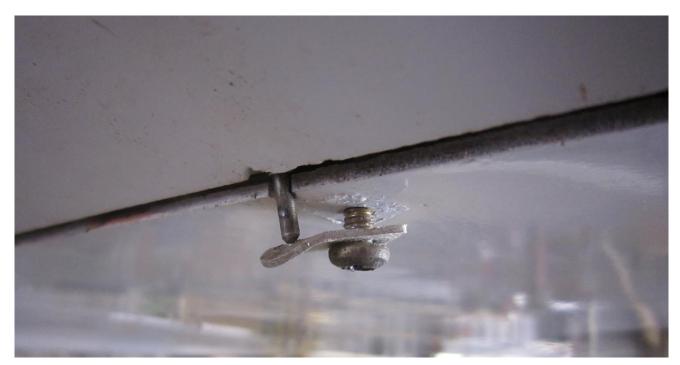
2) For each hinge – loosen the screw holding the locking tab so that the locking tab releases the end of the hinge pin. If the aircraft doesn't use this method of retaining the hinge pin, do what is necessary to release the pin so that it can be checked as described in step 3.

Figure 3: Hinge pin unlocked

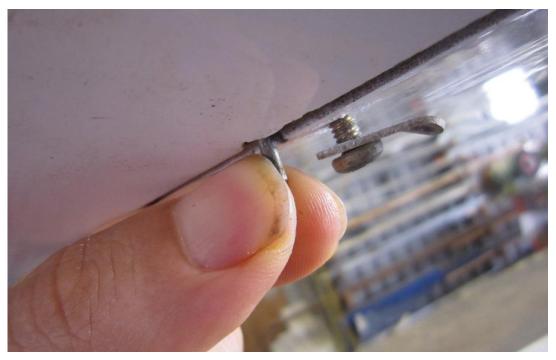
3) Now try to rotate the unlocked hinge pin radially in the hinge using your fingers. If it is stiff or can't be moved check if this is due to corrosion. If the hinge is corroded corrective action is required. If it is not corroded and the locking screw and tab are in satisfactory condition relock the hinge pin.

Figure 4: Moving hinge pin
