SERVICE BULLETIN: JSB 004-4

Subject: Jabiru Engine Oil Pump / Cooler

Affected Models: Jabiru 2200 and 3300 engines

Affected S/No: 2200A S/No. up to 22A1958

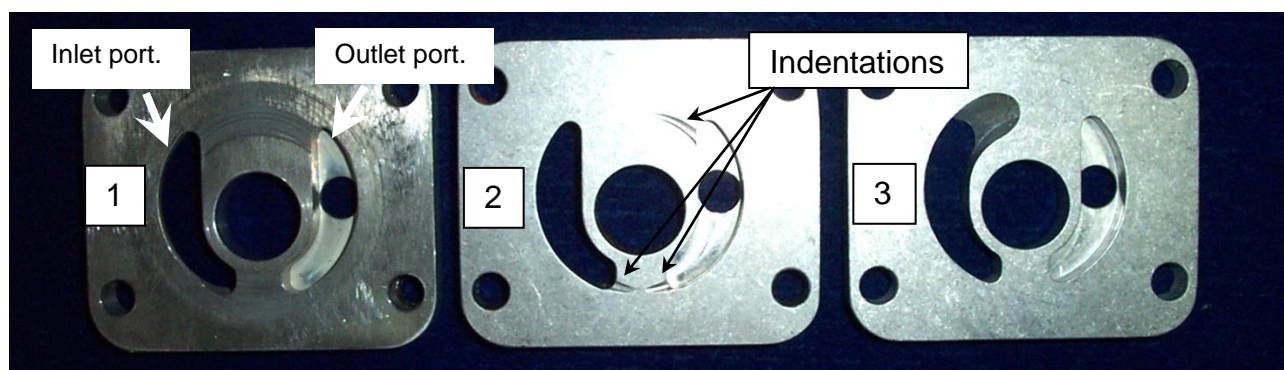
Figure 3. Port Plate Evolution

Plate #1: This is the original design, with the port plate outline unbroken by indentations.

Plate #2: This is a more recent design. At the top of the outlet port and at the bottom of both ports there are small tapered indentations. Some versions of this plate will only have the larger indentation at the top of the outlet port, and not the pair at the bottom.

Plate #3: This is the current plate design. The small indentations have been replaced by a large tapered cut at the top of the inlet port. Changes have also been made to the other side of the plate (which faces the crank cases) to remove sharp edges & reduce cavitation.

Plates like Plate #1 & Plate #2 can be modified to be equivalent to Plate #3. Where the plate already has the indentation on the top of the outlet port, care must be taken to leave at least 2mm between it and the end of the new cut on the inlet side.
