Jabiru Aircraft Pty Ltd
PO Box 5186
Bundaberg West QLD 4670
Australia

6th July 2014

To Owners, Operators and Maintainers of Jabiru Engines:

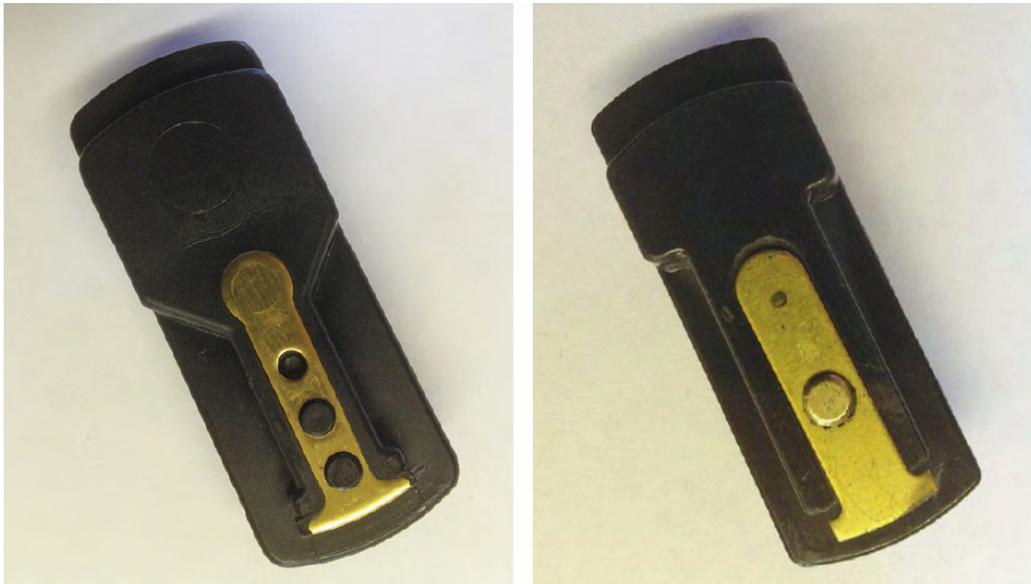
Recent articles in the "Safety Spot" column of the Light Aircraft Association in the UK have alerted Jabiru Aircraft (Australia) to the potential frequency of an issue regarding the distributor caps and distributor rotors used in some Jabiru engines. The issue occurs when the housing for the spring-loaded central carbon brush rubs against the rotor as it turns. Over time in service the friction in this area "welds" the rotor to the cap and in some cases has led to a failure of the rotor and so of the ignition. Details are available in the June and July 2014 LAA "Safety Spot" articles, available through the LAA website; www.lightaircraftassociation.co.uk/Magazine/LAMain.htm

Figure 1 – Distributor Caps (Photo: LAA Safety Spot June 2014)

The number of incidents regarding these parts reported to Jabiru (Australia) up until the LAA article had been very small and identified damage to the parts but no engine stoppages or ignition failures. In response, a minor production change was made to the length of the rotor shaft which ensures cap/rotor clearance for all versions of the parts. The altered shaft remains compatible with the original Bosch components.

It is a requirement to remove the distributor cap and inspect the rotor at each 50 hour service interval so in most instances any damaged parts will have been identified and replaced by now. If damaged parts are found they can be returned for replacement within the warranty period. Maintainers must familiarise themselves with the correct procedure to replace these parts (Section 9.12 of the current Jabiru Engine Maintenance Manual – Document JEM0002-3) as the rotors must be glued in place. Also note that using excess glue can cause a hydraulic lock, preventing the rotor from seating properly in place; maintainers must ensure that the rotor is properly in place on installation.
