Airworthiness Directive: 109

Date: February 15, 1996

Subject: S-12XL Airaile Nose Gear

Models Effected: S-12XL Airaile

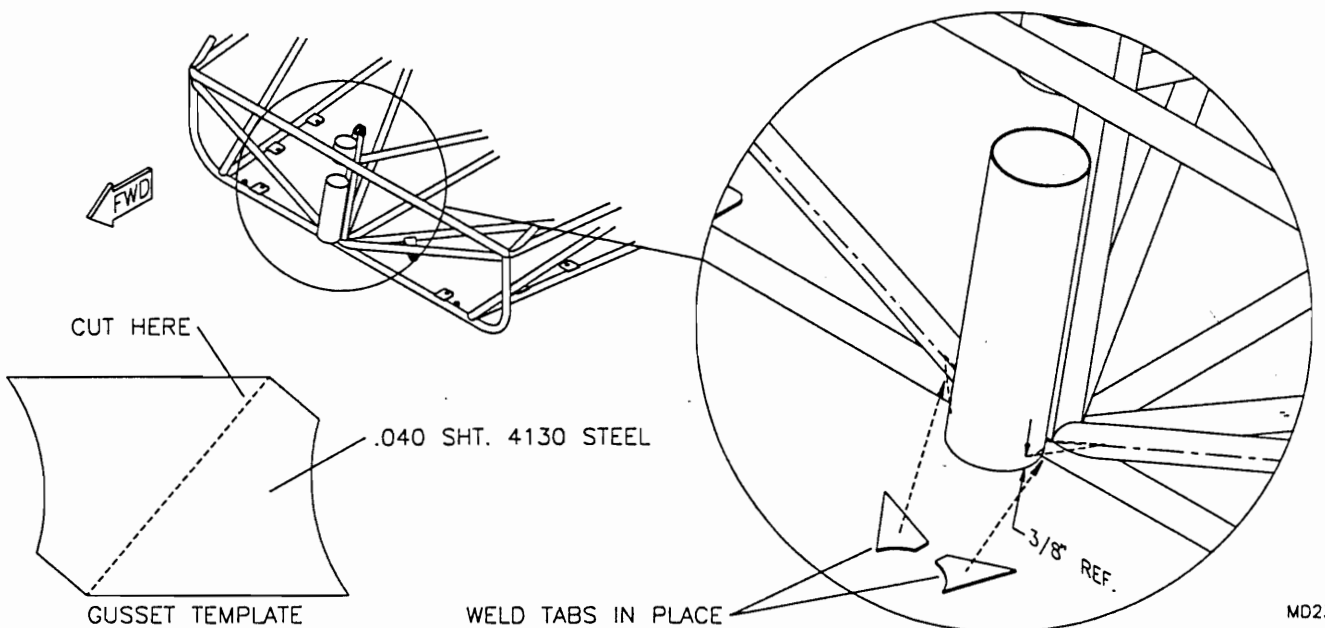
MD2399

We have had one in field failure of the lower swivel bushing on the fork. As a result the nose gear can separate and result in loss of directional control on landing roll out. The aircraft experiencing the failure is used extensively for in flight training on a rough runway. There was a total of 30 hours on the aircraft at the time of the incident.

Inspect the lower swivel bushing for cracks at the bottom edge of the square tube. If cracks are found do not operate until a reinforcement gusset is welded in place. Gussets can be fabricated as per the enclosed drawing or obtained from our Parts Department at no cost. Approved methods of welding are TIG, MIG or gas acetylene. Weld the gusset to the lower swivel bushing as per illustration. Welding can be performed in the aircraft's upright position.
