RANS

Airworthiness Directive: 136

Subject: Hour meter oil pressure switch leak

Models Affected: All RANS aircraft with ROTAX 912 engines equipped with an oil pressure switch for hour meter

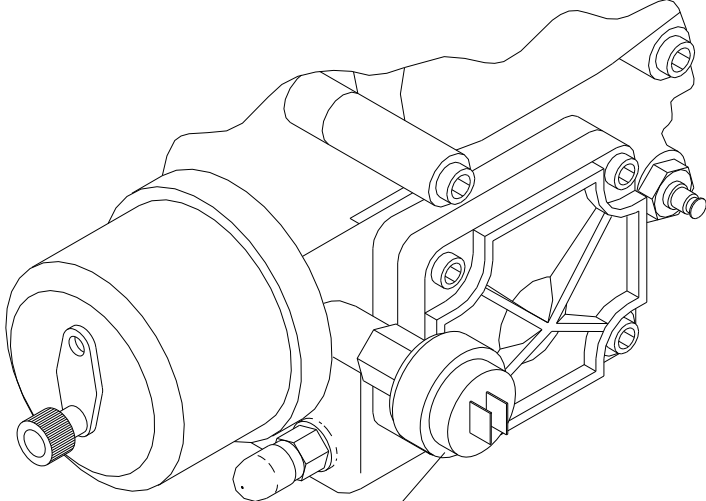
Inspection Location:

It has been brought to our attention that failures have occurred in the internal seal of the Oil Pressure Switch (RANS P/N KSES0004). This has caused premature loss of oil resulting in engine failure.

INSPECT FOR OIL LEAK HERE

Inspect for leaks before next flight. If leaks or defects are found, remove the aircraft from service until it is possible to replace the oil pressure switch with a 1/8" pipe plug and install Hour Meter Relay Assembly.

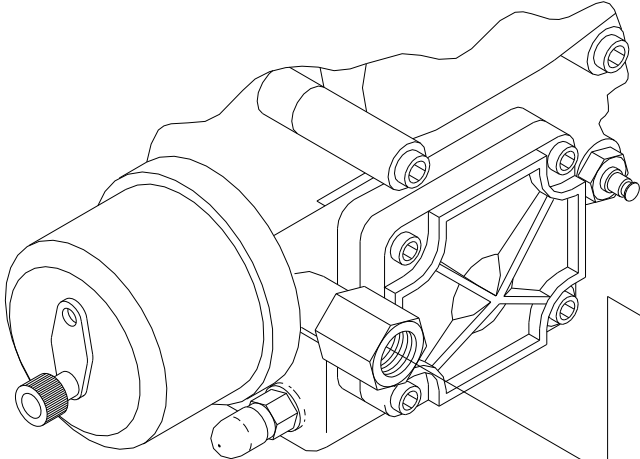
Oil Switch Removal:

REMOVE OIL SWITCH

REPLACE WITH PLUG*

*USE TEFLON TAPE WHEN INSTALLING PLUG
