Assembly Alert: 171

Date: July 2, 2010

Subject: Main Wheel Brake Line Failure with Wheel Pant Installation

Models Affected: S-19

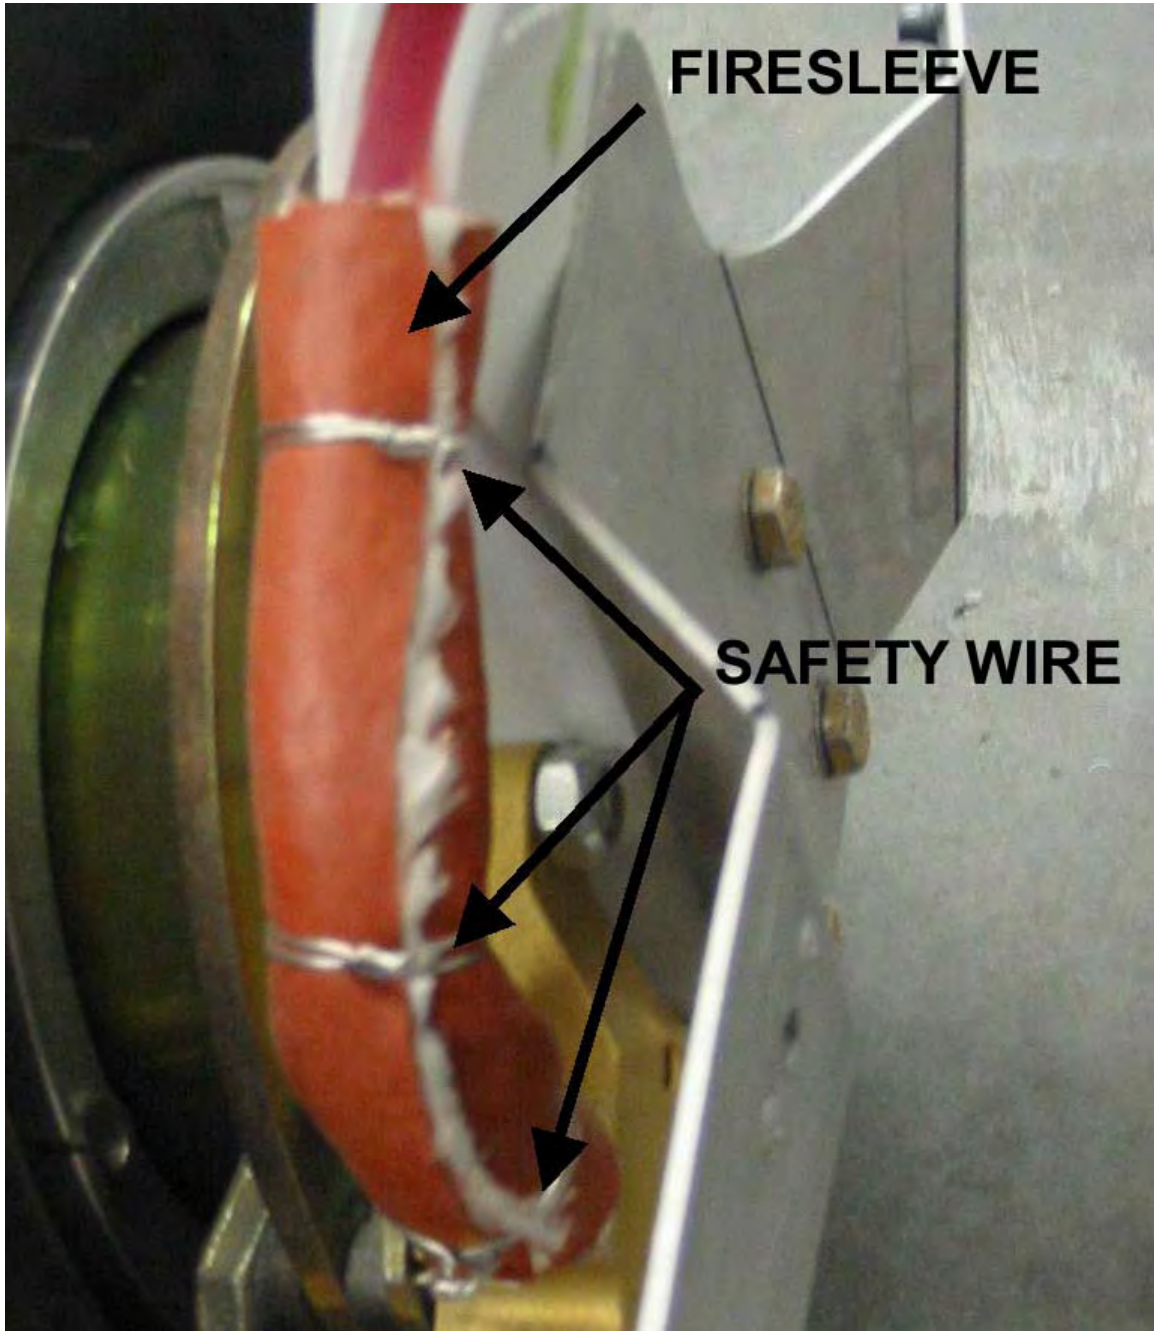
FIGURE AA171-1

Several S-19 owners have experienced over-heating, subsequent deformation and failure of the brake line at the main wheels, when wheel pants are installed. Possible brake line failure can be avoided by proper braking management while taxiing to prevent excessive brake heating.

RANS recommends the addition of fire-sleeve to the brake fitting and brake line at the main wheels. Refer to **FIGURE AA171-1**.

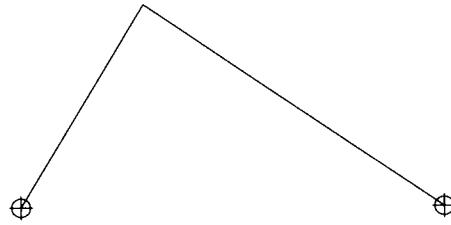
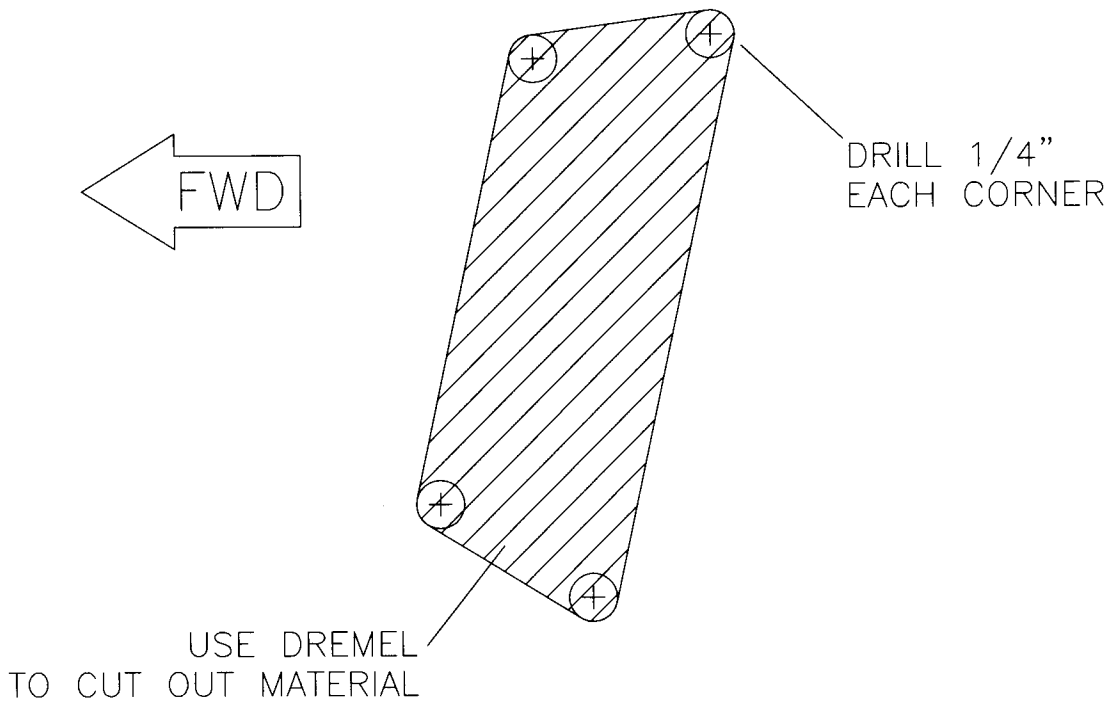
RANS S-19
WHEEL PANT MODIFICATION
FIGURE AA171-2

CENTER ON AFT INNER
WHEEL PANT ATTACH HOLES.
CUT AS SHOWN.

The addition of a cooling opening to the inboard side of each wheel pant will also aid in the removal of unwanted heat. Refer to **FIGURE AA171-2**.
