# RANS

**Operational Alert:** 158  
**Date:** August 20, 2003  
**Subject:** Nose Gear Disconnect & Shimmy Damper  
**Compliance:** Mandatory  
**Models Effected:** S-6 & S-16 Trike Configurations

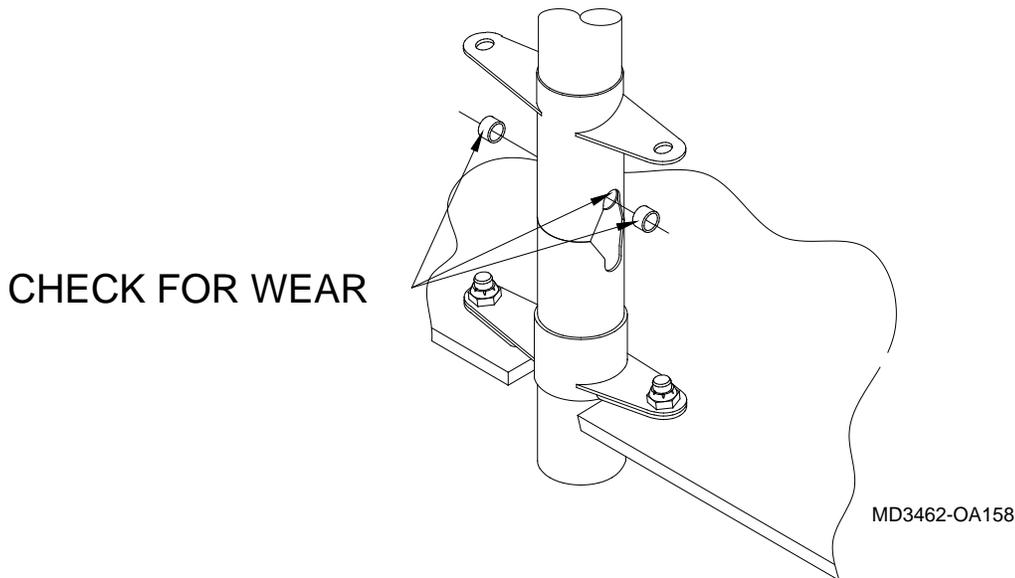
**FIGURE 1**

Nose Gear shimmy may occur if Nose Gear Disconnect components become worn. Inspect the 3/8" Steel Roller Bushing for grooving at every oil change. See FIGURE 1. Check for play between Steer Cam and Roller Bushing. Replace affected parts if play or wear is detected.
