Operational Alert: 173

Date: May 24, 2013

Subject: Trim Wire Breakage

Models Affected: All Models using Push-Pull Wire Trim System

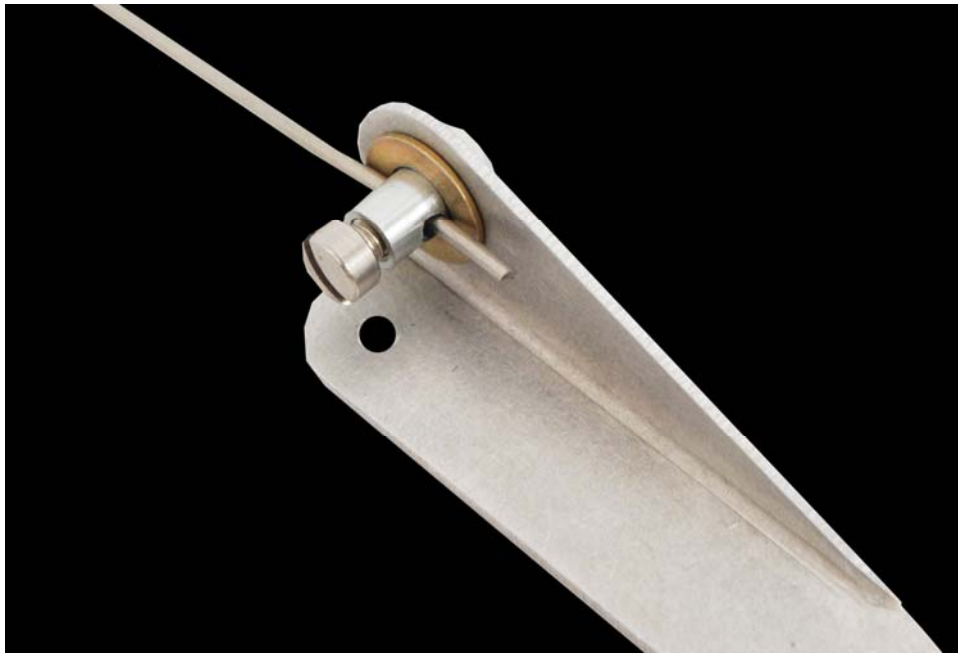
FIGURE 1 - Proper installation of Wire Swivel allows free rotation.

1. Inspect during pre-flight. Look closely at the wire where it terminates at the wire swivel. This should be secure and properly assembled with appropriate hardware. The intent of the design is to capture the wire with the wire swivel, while allowing the wire swivel to pivot freely in the trim tab horn. **IMPORTANT:** *The wire swivel must pivot freely when the trim wire is final installed with the wire swivel retaining screw fully tightened.* Refer to **FIGURE 1**.
2. Replace any suspect push-pull wire with proper spec wire. Contact RANS Parts Department to order.
3. If the push-pull wire has been bent, it needs to be replaced. See **FIGURE 2**.
4. Consider installing an electric trim servo. Several builders have created systems to install the Ray Allen brand of servos. We may be offering a factory made kit for this option.

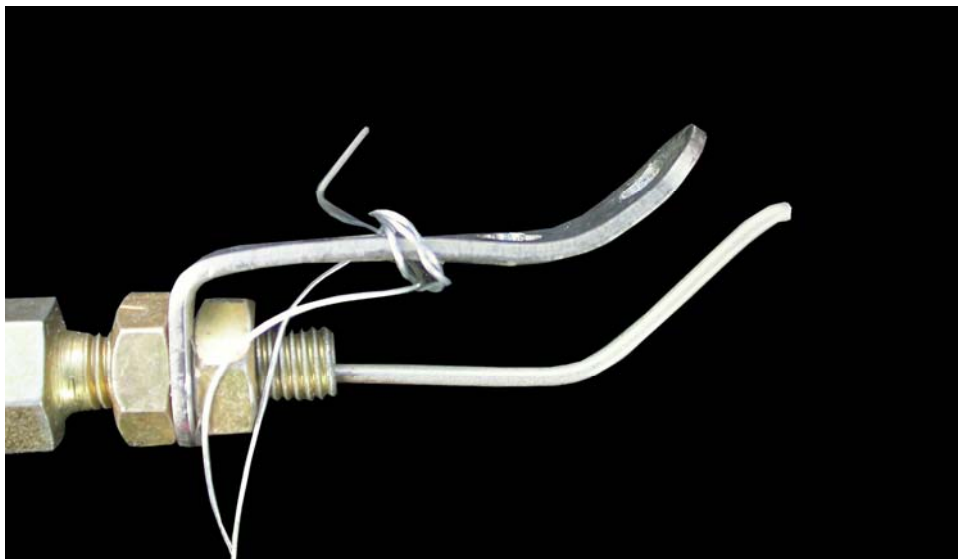
A pilot of an S-12XL experienced an in-flight trim tab flutter due to the push-pull wire breaking. Inspection of the wire suggests possible fatigue due to over bending.

FIGURE 2 - Not replacing bent push-pull wire may lead to failure!
