Operational Alert: 182

Date: July 14, 2017

Subject: Muffler Output Exit Pipe Cracking

Models Affected: All S-6 with Rotax 912 series engines

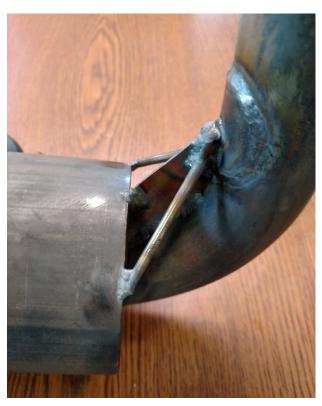
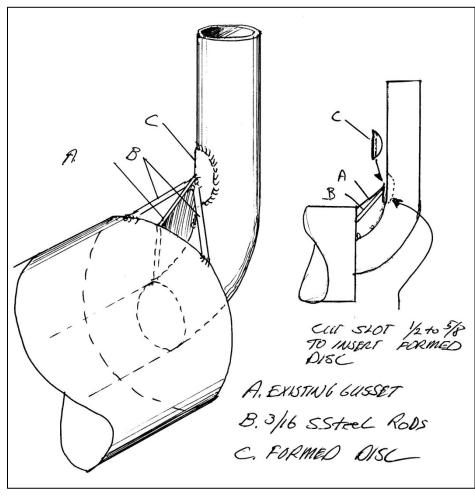
Some operators have reported cracks in the output pipe of the exhaust system. These have appeared on low time (under 200 hours) and high time (700 hours) exhaust canisters. These cracks can appear in the area shown in the photos, but are not isolated to these areas.

Please remove the top and bottom cowling and inspect your exhaust system thoroughly prior to the next flight. The use of a high intensity LED light will enhance the ability to see hairline cracks. Exhaust system inspection should be included in your annual condition inspection.

If you find cracking or want to take preventive measures, either return the exhaust canister to RANS or modify as per the photo and illustration below. There is no charge for the modification, however we ask you to pay shipping both ways.
