Release Date: 15th July 2015

SERVICE BULLETIN: JSB 029-2

Issue: 2

Subject: Jabiru J170 Handling Upgrade

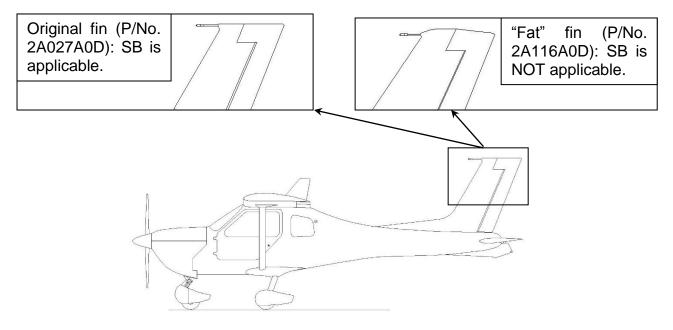
Figure 1 - Fin Identification

All using fin P/No. 2A027A0D

- Issue 1 was applicable to "all variants of the Jabiru J170 model". With subsequent changes to the basic J170 configuration and the advent of the J170-D aircraft this applicability was no longer valid.
- Accordingly, Issue 2 has been prepared to clarify and limit the applicability of the bulletin.
- J170 configurations to which this bulletin is NOT applicable are most easily identified by their use of a "fat" tail fin, P/No. 2A116A0D. The most easily identified feature is the shape of the tip of the fin as shown in Figure 1.

- J170-D aircraft.
- Any J170 aircraft which has been fitted or retrofitted with P/No. 2A116A0D "fat" vertical tail fin assembly.
- Any J170 aircraft which was modified in accordance with Issue 1 of this bulletin complies with the requirements of Issue 2. No additional work is required for these aircraft.

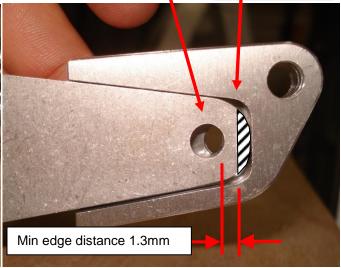
Figure 4 – Fitting Adaptor to Drive Arm

Align holes in extension with hole in original arm.

Cut off tip of existing arm

Use the 3/16" hole in the adaptor as a guide to drill a matching hole in the existing arm

- Apply the new drive adaptor to the existing internal flap drive arm from the outboard side it
 will be obvious how much material must be removed from the existing arm to fit the adaptor.
 Figure 4 (right) shows this. Carefully remove this material, removing just enough so that the
 extension slides onto the arm far enough to align the bolt holes and to fit snugly around the
 arm. De-burr the tip. Note the minimum edge distance shown in Figure 4 (right).

- The adaptor can now be placed on the inboard side of the flap drive arm and used as a guide to drill the new 3/16" hole. Carefully drill through the hole on the adaptor and through the existing drive arm.

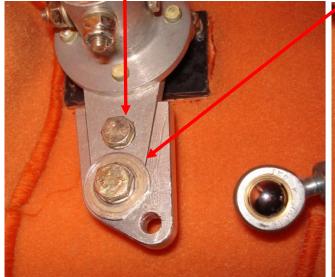
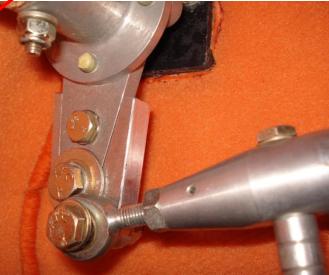
Figure 5 - Adaptor in Place

Adaptor bolted & bonded in place. Use of penny washer is optional.

- Remove the adaptor from the drive arm. Clean it using Acetone. Mix and apply 5-minute epoxy resin to its socket.
- Bolt the adaptor to the arm using 1 off ½" and 1 off 3/16" bolts, orienting it as shown in Figure 5. Wipe off any excess resin. Both bolts can be fitted from the cabin side of the drive arm care will be needed to use the correct length bolt so that the tails of the bolts do not rub on the side of the fuselage. If required AN363 or MS21042 nuts may be used as they are thinner than Nylock-type nuts.

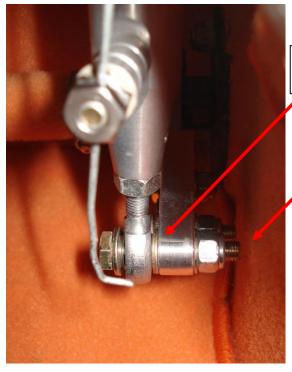
Figure 6 - Flap Drive Modification

bolt and fuselage side

Note clearance between

Spacer washer to prevent

drive shaft binding

- Turn the aircraft master power on and drive the motor to the fully "down" position, then turn the master power off.
- Once in position, adjust the rod end in the motor shaft to align with the lowest hole in the adaptor and re-connect it using a ¼" bolt. Note that if there is not enough adjustment in the rod end the external flap drive pushrods can be adjusted to suit. Again, AN363 or MS21042 nuts may be used if required to give clearance from the fuselage.
