SERVICE LETTER: JSL022-1

Subject: Fuel Pump Drain.

Affected Models: All Jabiru Airframes.

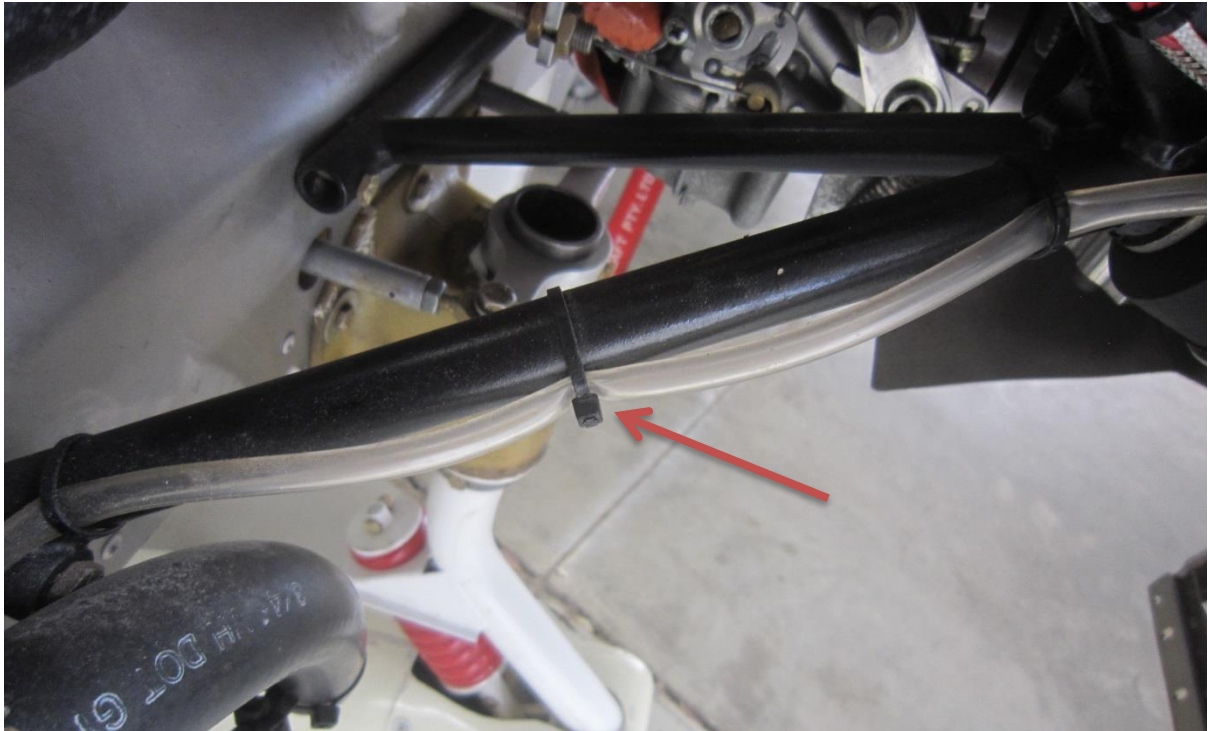
The mechanical fuel pump on the engine has a drain line that drains fuel away from the engine in the case of the diaphragm developing a leak. It has been found that if this line is blocked, operation of the fuel pump can be affected. The usual reason for blockage is that the ties that hold the drain line have crushed the drain line flat.

Figure 1: Crushed drain line.

If the fuel pump drain line is found to be blocked or as a preventive measure, the ties that hold the drain line can be changed to a configuration that won't crush the tube.

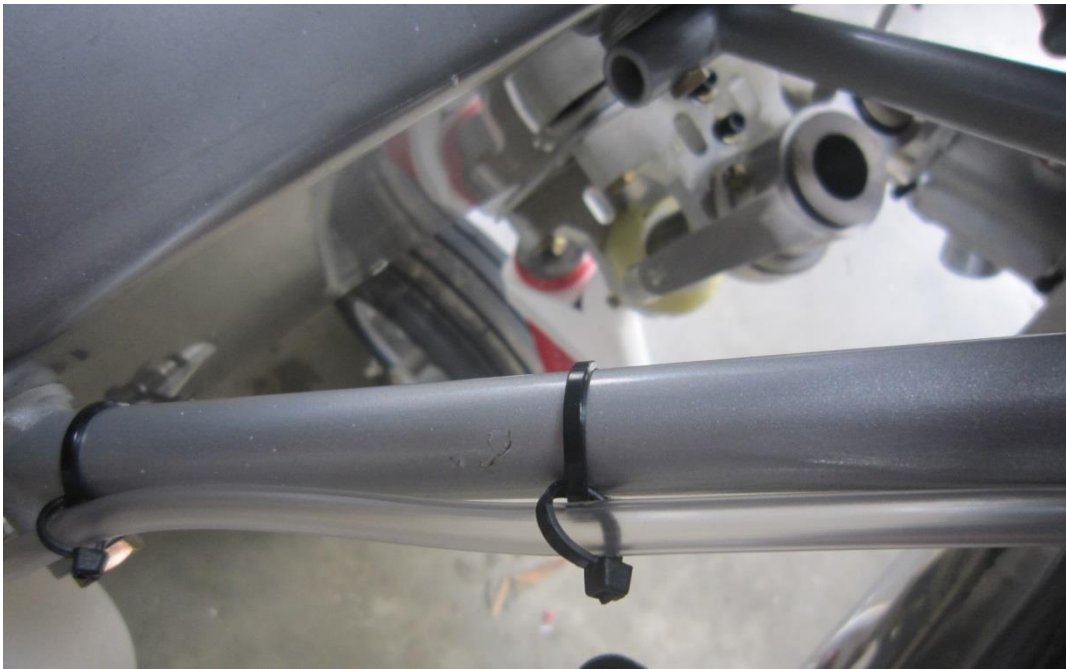
Figure 2: Anti-crush configuration.
